ARROWHEAD ELEMENTARY SCHOOL FACILITIES STUDY

June 4, 2019

KCBA – Architecture/Interior Design/Structural Eng.

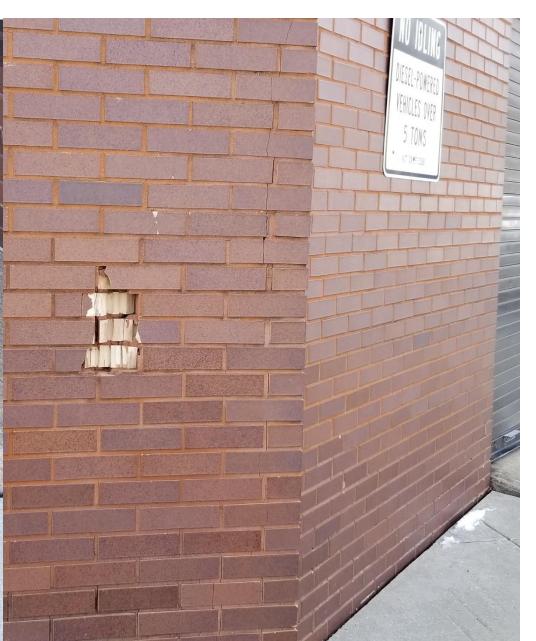
Exterior Building Analysis:

- Substandard existing building elements.
- Windows are aluminum frame with noninsulated (single pane) glass.
- Mortar is missing in multiple locations on each elevation.
- Brick is spalling off and missing in multiple locations on each elevation.

- 1. Numerous exterior repairs to roofing, bricks, and flashing needed.
- 2. Numerous interior repairs to building are needed.
- 3. All building systems need replacement and upgrade.
- 4. Educational environments and security protocol improvements needed throughout.

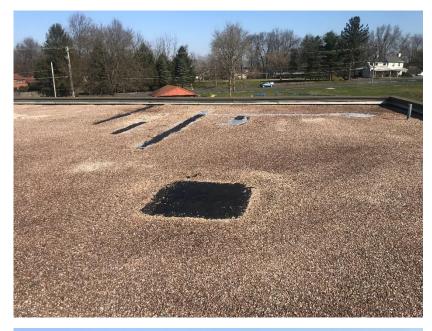
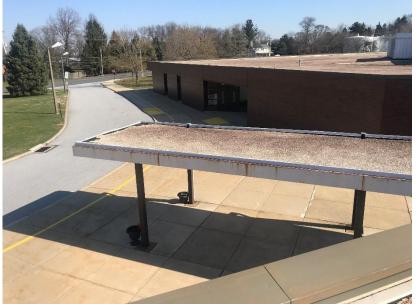
Exterior Building Analysis:

- Overall roof is in poor condition.
- Roof has reached the end of its lifespan.
- Several leaks detected inside the school.
- Steel structure of entrance canopy is rusting.

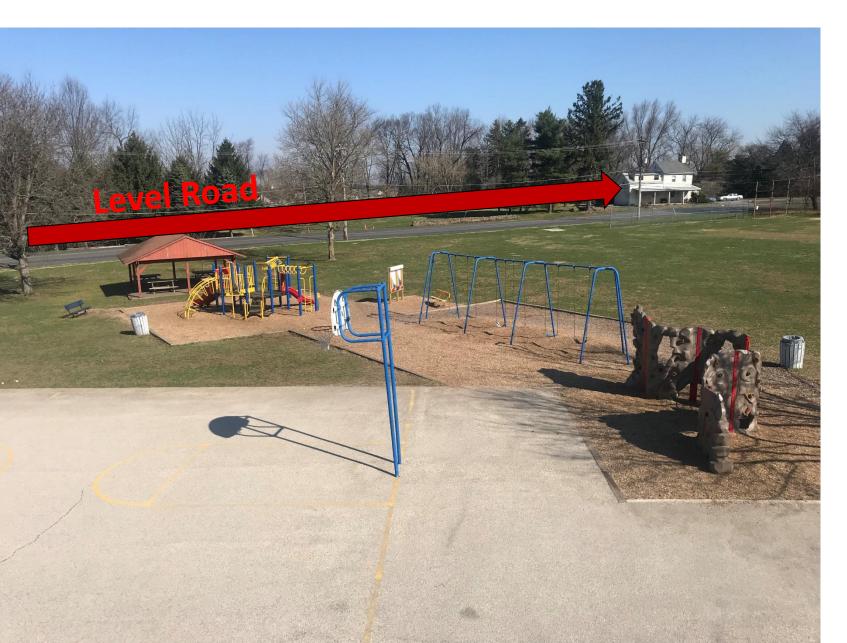
Exterior Building Analysis:

• Play area in front of school close to main road.

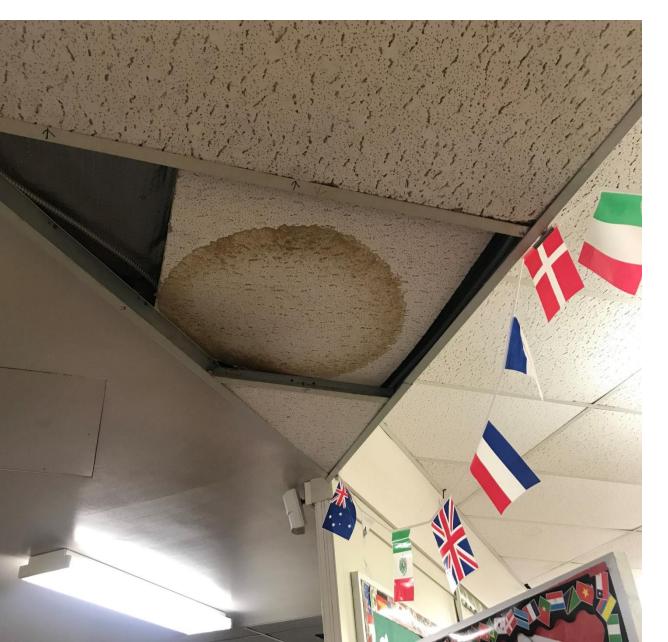
Interior Building Analysis:

- Modular floors have recently experienced moisture issues.
- Acoustical ceiling tile throughout building is sagging, chipped, and mismatched.

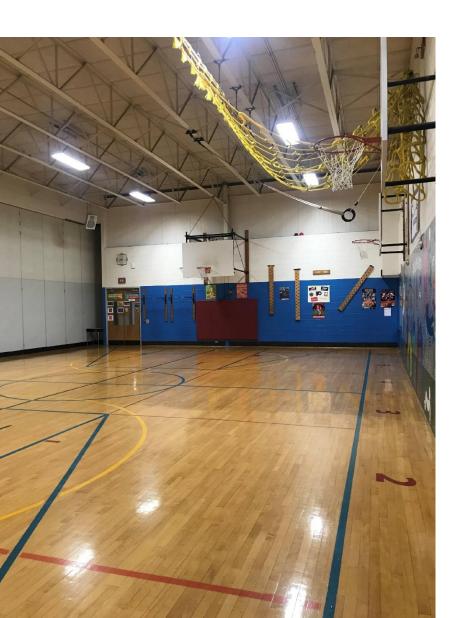
Interior Building Analysis:

- General lack of storage.
- Teacher equipment in hallways.
- Undersized Gym (lack of storage).

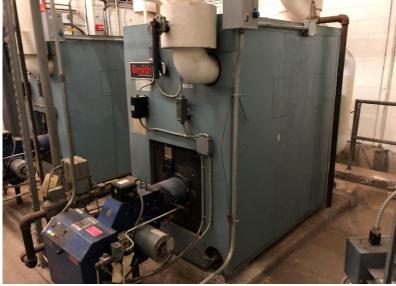
• Majority of HVAC systems are nearing the end of their useful life.

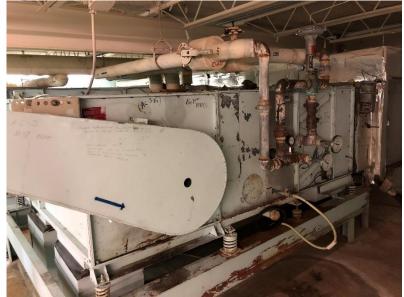
• The return air system is no longer acceptable by governing fire codes.

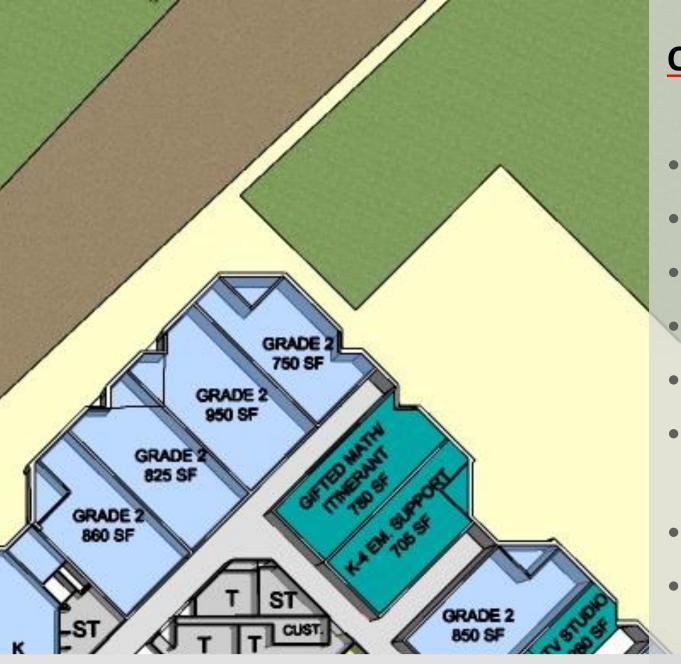
EXISTING FLOOR PLAN (58,534sf school with modulars)

Concerns with existing layout:

- Classroom sizes too small
- Teachers struggle with room shape
- Lack of Small Group Instruction
- Lack of exterior access for windows
- Modulars past their anticipated life
- Administration area disconnected from secure entry vestibule
- Gym/Cafeteria combo too small
- Instrumental Music in storage room

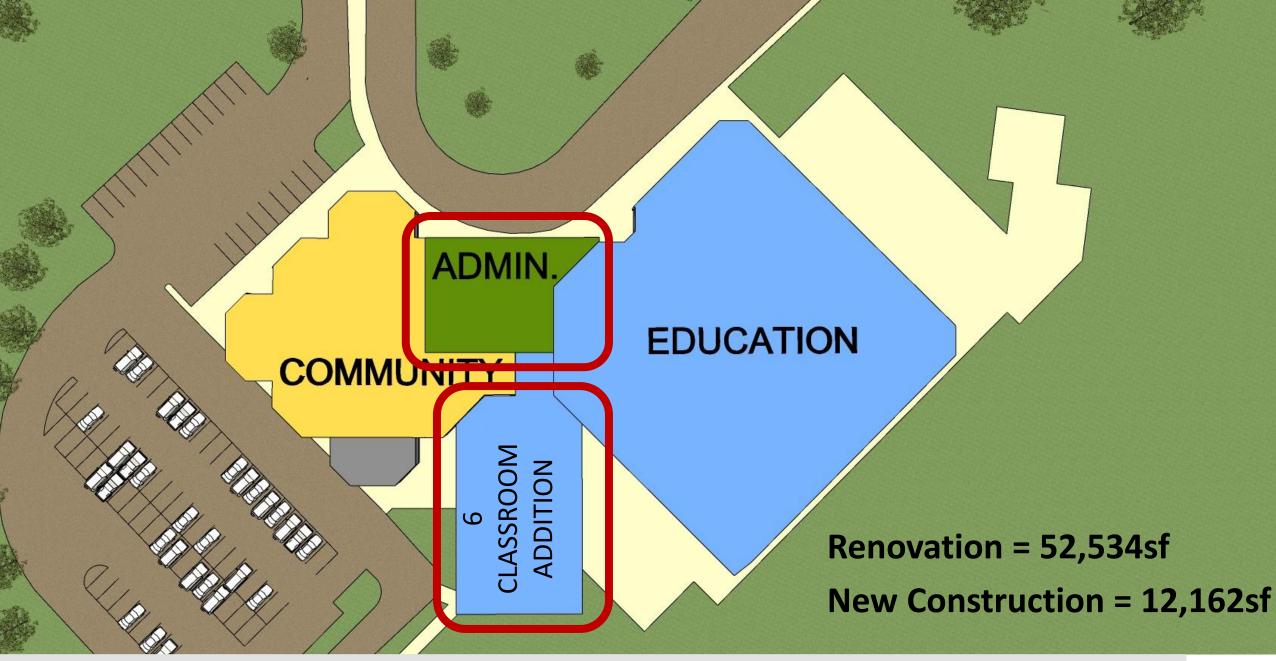
RENO+ADD OPT. #1 FLOOR PLAN – 525 Students (64,696sf School)

RENO+ADD OPTION #1 – CAPACITY 525

NEW SECURE ENTRY, REPLACE MODULAR CLASSROOMS, FULL DAY K

INCLUDES: ROOF REPLACEMENT, REPLACEMENT OF MOST BUILDING SYSTEMS (INCLUDING SPRINKLER SYSTEM) + SECURITY CAMERAS. ALONG WITH NEW SECURE FRONT ENTRANCE AND CLASSROOM ADDITION.

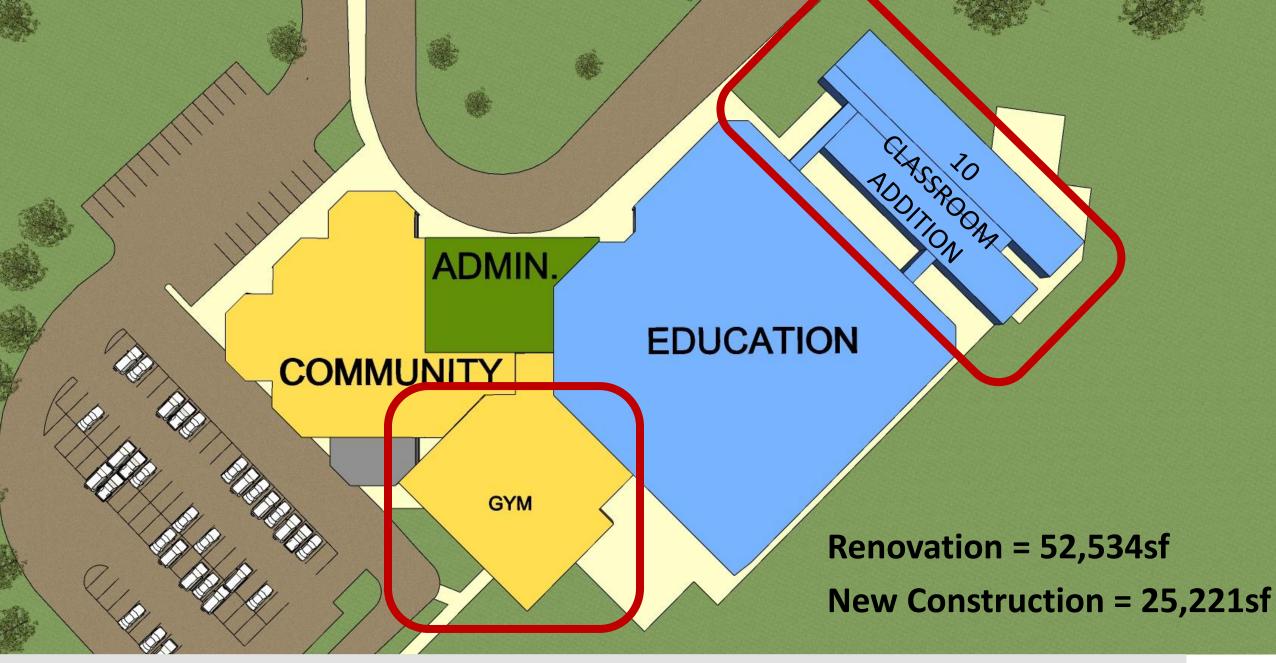
RENO+ADD OPT. #2A FLOOR PLAN – 525 Students (77,755sf School)

RENO+ADD OPTION #2A – CAPACITY 525

OPTION #1 AS WELL AS GYMNASIUM AND LARGER EDUCATIONAL ADDITION

INCLUDES: ROOF REPLACEMENT, REPLACEMENT OF MOST BUILDING SYSTEMS (INCLUDING SPRINKLER SYSTEM) + SECURITY CAMERAS. ALONG WITH NEW SECURE FRONT ENTRANCE, CLASSROOM ADDITION TO CLOSER MEET EDUCATIONAL PROGRAM, AND A NEW GYM.

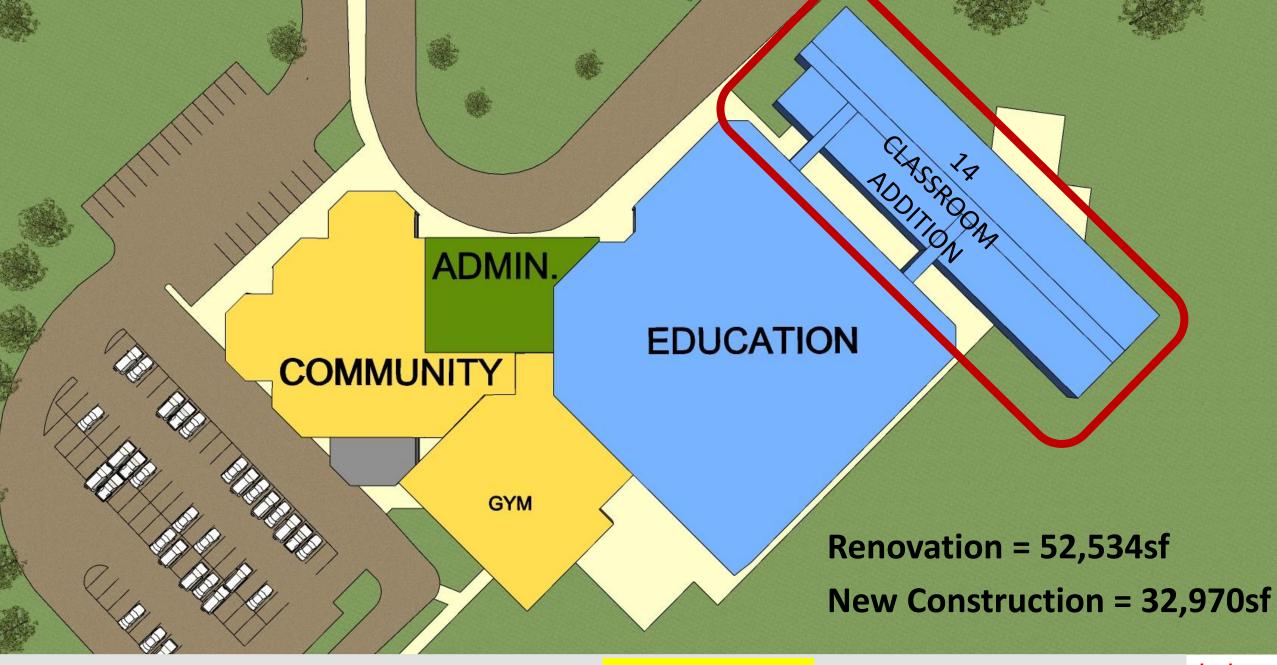
RENO+ADD OPT. #2B FLOOR PLAN – 625 Students (85,504sf School)

RENO+ADD OPTION #2B – CAPACITY 625

OPTION #1 AS WELL AS GYMNASIUM AND LARGER EDUCATIONAL ADDITION

INCLUDES: ROOF REPLACEMENT, REPLACEMENT OF MOST BUILDING SYSTEMS (INCLUDING SPRINKLER SYSTEM) + SECURITY CAMERAS. ALONG WITH NEW SECURE FRONT ENTRANCE, CLASSROOM ADDITION TO CLOSER MEET EDUCATIONAL PROGRAM, AND A NEW GYM.

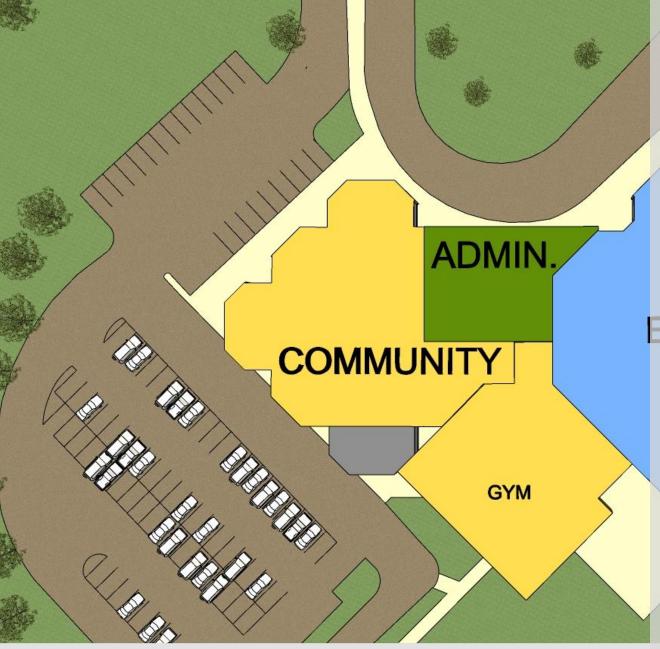
Renovation Summary:

- Improved entry security
- New classrooms created
- 2A/2B Options opportunity for community gym
- Existing classrooms still not ideal shape/proportion
- New classroom wing located away from core of school
 - Not all spaces located or sized as desired
- Limited site improvements
