# Eagleville Elementary School

Façade Replacement, New Addition + Renovations

February 16<sup>th</sup>, 2021 School Board Meeting

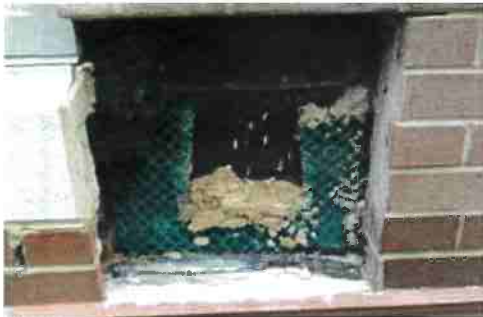
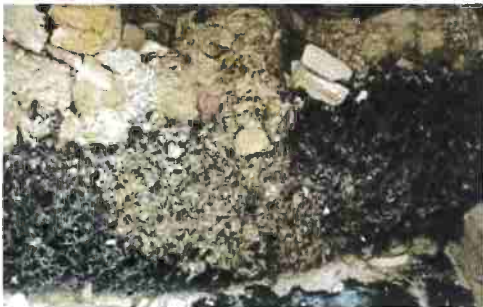
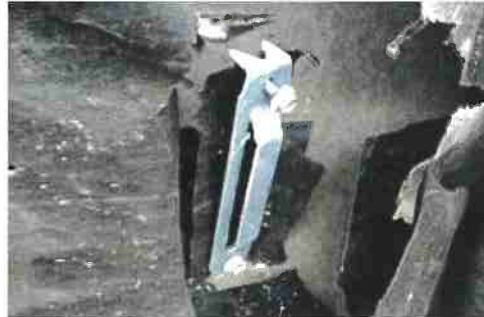
### Brick Veneer Ties

Adjustable dovetail brick ties were used to anchor the brick veneer to the back up wall in the stud wall construction section of the building. The ties were placed between 12" and 16" apart both horizontally and vertically. The ties are anchored with screws into the sheathing. It was found in some locations that the ties were anchored only into the sheathing and not into the stud behind. These ties could be pulled out of the sheathing with essentially no effort. This condition was also inconsistent throughout the areas reviewed. It is impossible to determine the number of ties that are secured properly to the stud and how many are only superficially anchored to the sheathing. In order for the veneer to be properly supported, all ties must be anchored back into the structure of the back up wall. The existing ties showed no signs of corrosion.

In the CMU portion of the building, the ties are integrated into the joint reinforcing of the CMU back up wall. Ladder type reinforcing was placed in the bed joints of the CMU with eyelets for the installation of the brick ties. All of the brick ties reviewed were secure and in good condition. The only

inconsistency found in the brick ties was at the top of the wall. The CMU is in the same plane as the structural steel at the roof level. Without CMU at the steel level, there was no where to install the veneer ties. Ties at this location were either installed in the sheathing or missing.

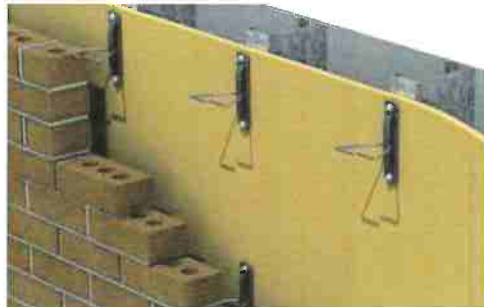
Diagram showing how masonry ties are to be anchored.

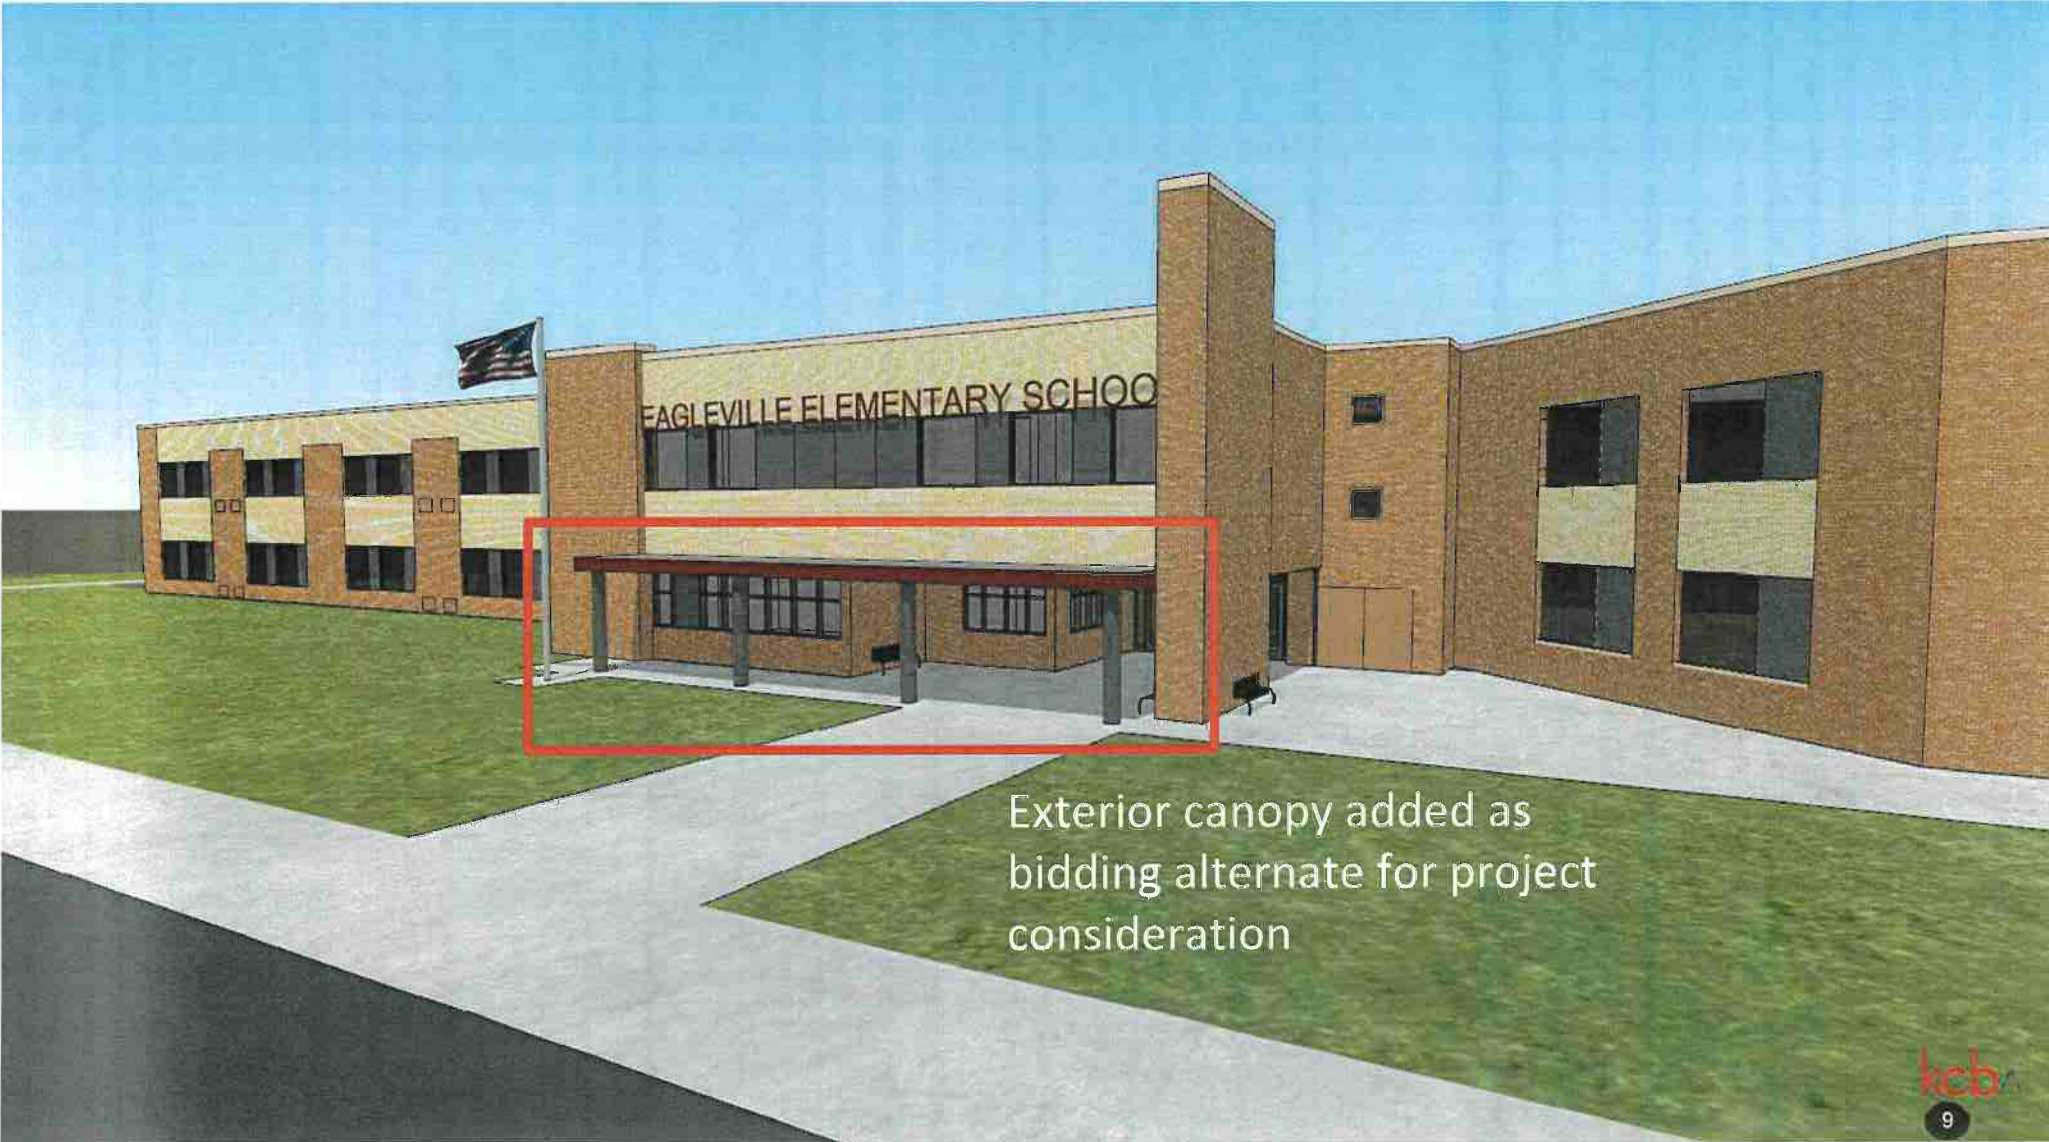
Exterior canopy added as  
bidding alternate for project  
consideration

## Benefits of Canopy

- Shelter students on exterior of building for fast cueing during bus dismissal
- Structure provides an added measure of security
- Allows for outdoor classes – particularly beneficial in the current health climate
- Protect the exterior building and provide shade for the administration windows. Energy savings

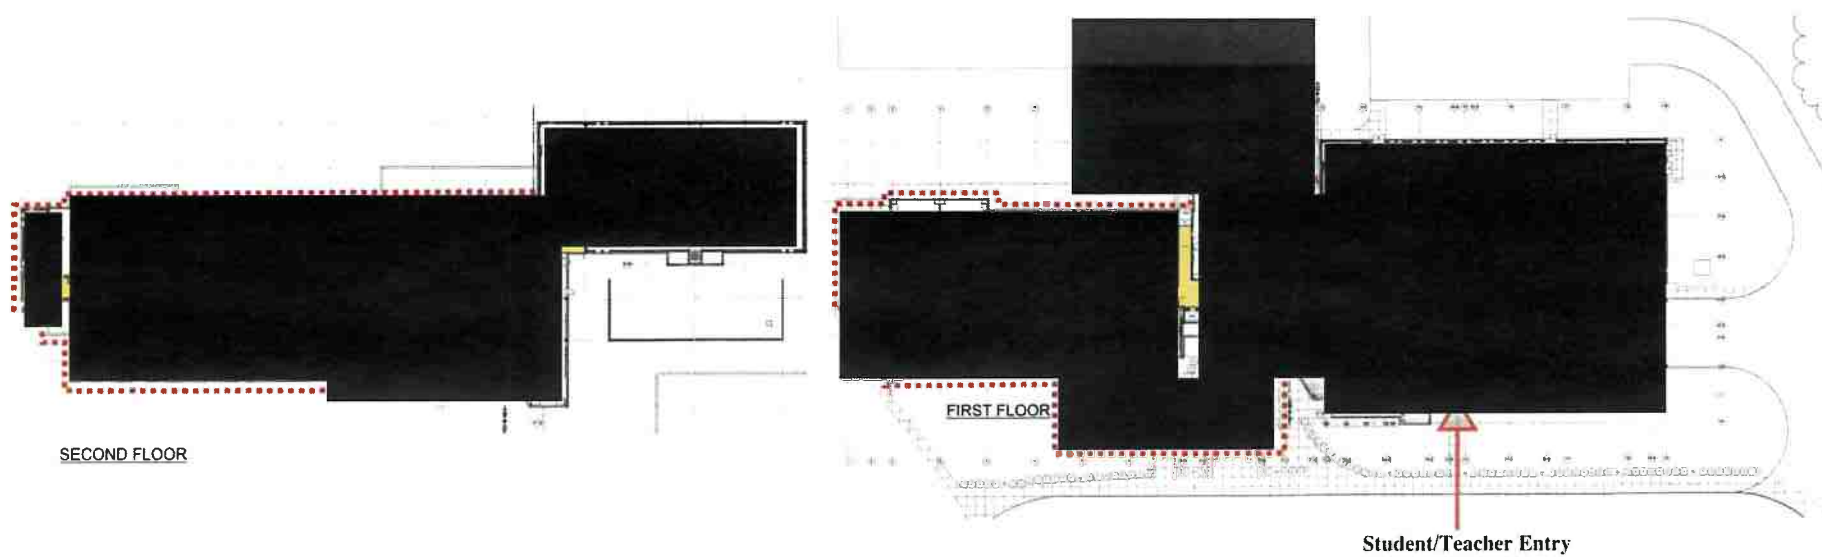
## EAGLEVILLE ELEMENTARY CONSTRUCTION PHASE 1

Remove corridor ceilings  
Temporary hang lights and Fire alarm devices  
Begin installing new mechanical piping -2nd shift  
Mechanical work in Mechanical rooms  
Begin demolition of existing brick and re-install  
Begin footings and Foundations for new addition
